Manhole Inspection Summary

Manhole # S35G__071MH

Insp Date: 1/15/09 9:12 AM

Location Address: **37 s charles st**

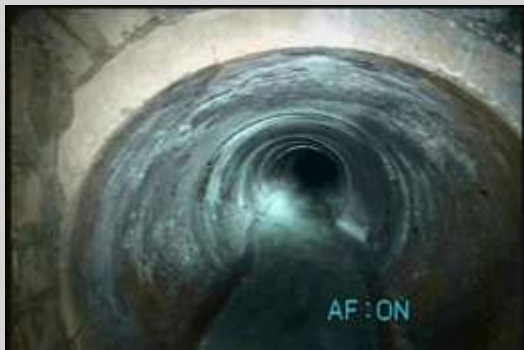
12 O'Clock Outflow

21 in. Circular Gravity Sewer
Pipe Out @ 12 O'Clock

Invert Depth: 17.25 (ft.) Flow Characteristics: **Fast**

Infiltration: **None** Pipe Seal Cond: **Unknown**

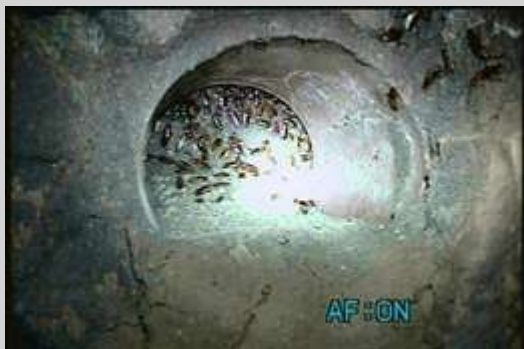
3 O'Clock Inflow

12 in. Circular Gravity Sewer
Pipe In @ 3 O'Clock

Infiltration: **None** Pipe Seal Cond: **Unknown**
